**Flood Control Project Maintenance
Levee Inspections**
LMA District Cover Sheet
Spring 2018 Levee Inspection Results

Sutter Maintenance Yard Hamilton Bend

Waterway			Bank	Unit Miles
Unit No. 01 Feather River Hamilton Bend			Right	3.39
	Spring (March - May)	Summer (June - August)	(September - November) Fall	Winter (December - February)
Unit Maintenance Rating (Fall Only)				
Date of Inspection	3/20/2018 - 3/20/2018			
DWR Inspector	Sterling York			
Accompanied By	Shawn Freitag Sutter Maintenance Yard

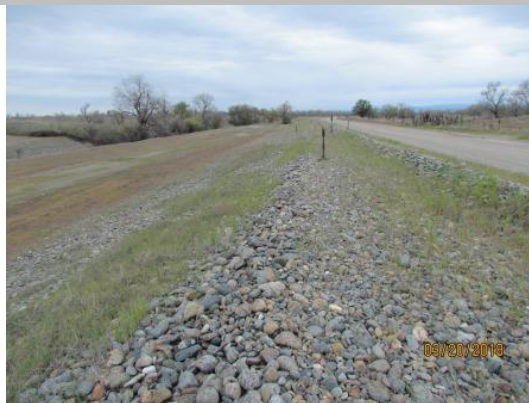
Photo 1 of 1 : SP_2018_ST0005_289_12_20180409_00018.jpg

LM Start	0.01	Rating **	A	Issue No.	12
LM End	1.22	Issue Type +	Ma	Location *	LS
Category	Earthen Levee			GPS Latitude/Longitude	
				Start	End
Item	Vegetation			39.439848 °	39.456805 °
				-121.641469 °	-121.639315 °
DWR ID	DWR_ST0005_01_s_2018_12				
Comment Code					
V1 : Control annual grass and weeds on the levee slopes and easements.					
Inspector Comment					
The annual vegetation is well maintained, Spring 2018.

View looking upstream landside of well maintained annual vegetation, Spring 2018.

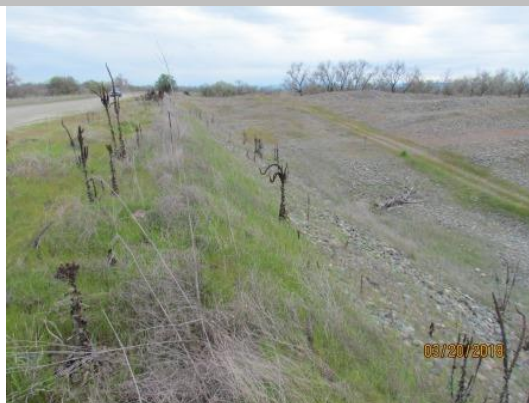
Photo 1 of 1 : SP_2018_ST0005_289_13_20180409_00019.jpg

LM Start	0.01	Rating **	A	Issue No.	13
LM End	1.22	Issue Type +	Ma	Location *	WS
Category	Earthen Levee			GPS Latitude/Longitude	
				Start	End
Item	Vegetation			39.439848 °	39.456805 °
				-121.641469 °	-121.639314 °
DWR ID	DWR_ST0005_01_s_2018_13				
Comment Code					
V1 : Control annual grass and weeds on the levee slopes and easements.					
Inspector Comment					
The annual vegetation is well maintained, Spring 2018.

View looking upstream waterside of well maintained annual vegetation, Spring 2018.

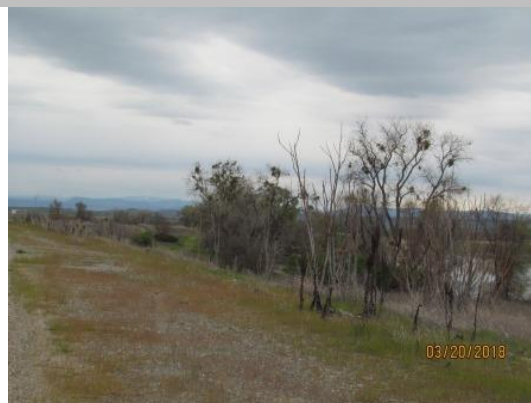
Photo 1 of 1 : SP_2018_ST0005_289_14_20180409_00020.jpg

LM Start	0.73	Rating **	A/W	Issue No.	14
LM End	0.91	Issue Type +	Ma	Location *	WS
Category	Earthen Levee			GPS Latitude/Longitude	
				Start	End
Item	Trim / Thin Trees			39.450109 °	39.452643 °
				-121.640851 °	-121.640316 °
DWR ID	DWR_ST0005_01_s_2016_14				
Comment Code					
T3 : Trim and thin trees to allow visibility of the ground and room to flood fight.					
Inspector Comment					
Small trees 4" in diameter at chest height have been sprayed and should be removed, Spring 2018.

View looking upstream waterside of trees. Small trees 4" in diameter at chest height have been sprayed and should be removed, Spring 2018.

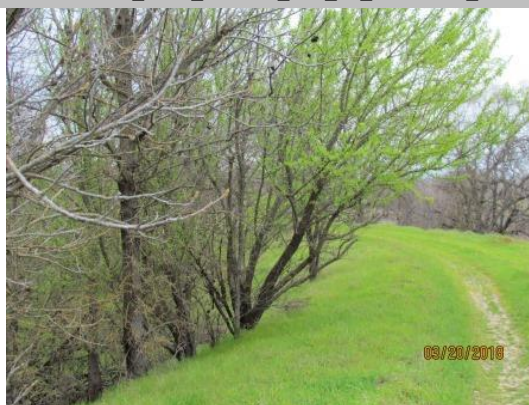
Photo 1 of 1 : SP_2018_ST0005_289_11_20180409_00021.jpg

LM Start	1.48	Rating **	U	Issue No.	11
LM End	3.25	Issue Type +	Ma	Location *	LS
Category	Earthen Levee			GPS Latitude/Longitude	
				Start	End
Item	Trim / Thin Trees			39.458055 °	39.470312 °
				-121.636300 °	-121.609242 °
DWR ID	DWR_ST0005_01_s_2017_11				
Comment Code					
T3 : Trim and thin trees to allow visibility of the ground and room to flood fight.					
Inspector Comment					
From Levee Mile 1.38 to 3.39 has never been maintained by the LMA.

View looking upstream landside of thick trees blocking visibility on landside, looking downstream. Spring 2018.

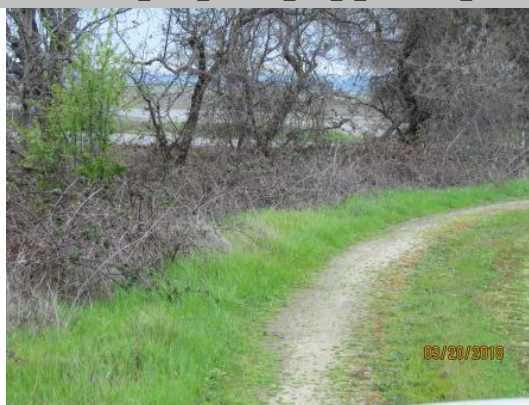
Photo 1 of 1 : SP_2018_ST0005_289_6_20180409_00023.jpg

LM Start	1.50	Rating **	U	Issue No.	6
LM End	2.63	Issue Type +	Ma	Location *	LS
Category	Earthen Levee			GPS Latitude/Longitude	
				Start	End
Item	Vegetation			39.458132 °	39.466025 °
				-121.635914 °	-121.618972 °
DWR ID	DWR_ST0005_01_f_2016_6				
Comment Code					
V2 : Remove the wild growth other than native grasses from the levee slopes.					
Inspector Comment					
Blackberries covering slope. From Levee Mile 1.38 to 3.39. This section has never been maintained by the LMA.

View looking upstream landside of blackberries that are covering the landside slope, Spring 2018.

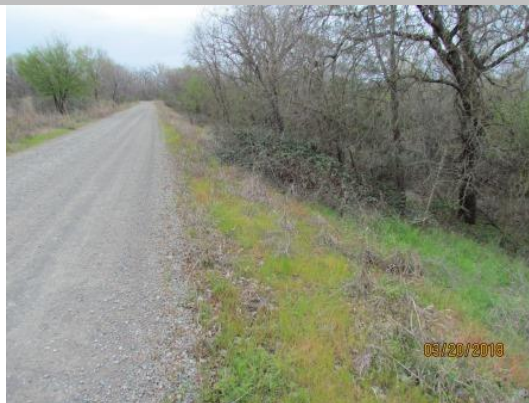
Photo 1 of 1 : SP_2018_ST0005_289_19_20180409_00026.jpg

LM Start	1.96	Rating **	M	Issue No.	19
LM End	3.23	Issue Type +	Ma	Location *	WS
Category	Earthen Levee			GPS Latitude/Longitude	
				Start	End
Item	Vegetation			39.461633 °	39.470064 °
				-121.629925 °	-121.609264 °
DWR ID	DWR_ST0005_01_s_2018_19				
Comment Code					
V1 : Control annual grass and weeds on the levee slopes and easements.					
Inspector Comment					
Maintain annual grasses and wild growth, Spring 2018.

View looking upstream waterside of annual grasses and wild growth that need to be maintained, Spring 2018.

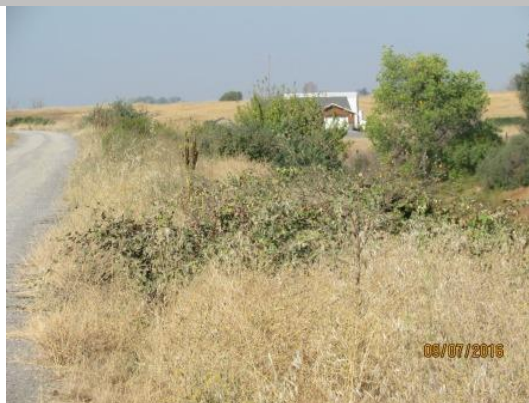
Photo 1 of 1 : SP_2018_ST0005_289_10_20180302_00005.jpg

LM Start	2.46	Rating **	M	Issue No.	10
LM End	2.48	Issue Type +	Ma	Location *	LS
Category	Earthen Levee			GPS Latitude/Longitude	
				Start	End
Item	Vegetation			39.465370 °	39.465410 °
				-121.622074 °	-121.621736 °
DWR ID	DWR_ST0005_01_f_2016_10				
Comment Code					
V2 : Remove the wild growth other than native grasses from the levee slopes.					
Inspector Comment					
Blackberry bushes are covering landside slope. From Levee Mile 1.38 to 3.39 has never been maintained by the LMA.

View of blackberries that are covering landside slope.

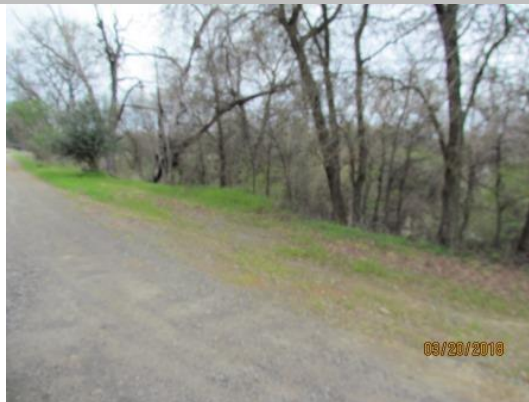
Photo 1 of 1 : SP_2018_ST0005_289_4_20180409_00027.jpg

LM Start	3.23	Rating **	M	Issue No.	4
LM End	3.27	Issue Type +	Ma	Location *	WS
Category	Earthen Levee			GPS Latitude/Longitude	
				Start	End
Item	Trim / Thin Trees			39.470063 °	39.470558 °
				-121.609264 °	-121.609215 °
DWR ID	DWR_ST0005_01_s_2013_4				
Comment Code					
T3 : Trim and thin trees to allow visibility of the ground and room to flood fight.					
Inspector Comment					
Small trees 4" in diameter at chest height should be removed before they get too big. From Levee Mile 1.38 to 3.39 has never been maintained by the LMA.

View looking upstream waterside of small trees 4" in diameter at chest height should be removed before they get to big, Spring 2018.

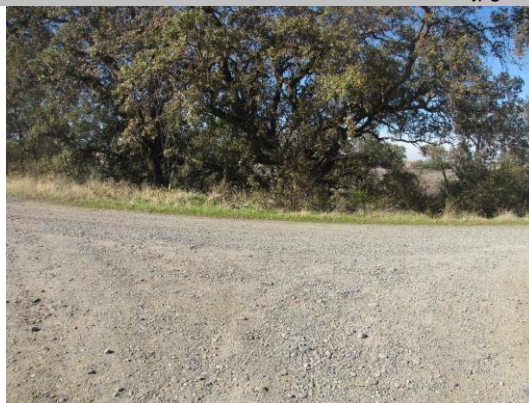
FS_ID:47972
DS_ID:17044
EP_NO: N/A
Repair Type: Non-Urgent
Crossing Status: Indicator Found
UCIP Comments: 4/26/2016 Unable to access area near structure.5/14/2013 Same as last inspection.11/14/2012
Abandoned Structure: WS- reminisce of gates and concrete standpipe;
LS-reminisce of concrete headwall and pump station.
FIELD_STRUCT_DESC: *ABANDONED* [Western Canal Head Gate Inlet Structure] 1 of 2: 96-inch by 96-inch (8-foot by 8-foot) reinforced concrete culverts through the levee 25 feet below the crown. Three slide gates on the waterside (WS) end. Concrete stairs on the WS slope. Concrete headwall at both WS and landside (LS) toes. [Additional Reference(s): DWR Levee Log, 2005. USACE Sacramento O&M Manual 152, March 1957 (Station 170+00)]
FS Date: 5/3/2016 12:36:00 PM

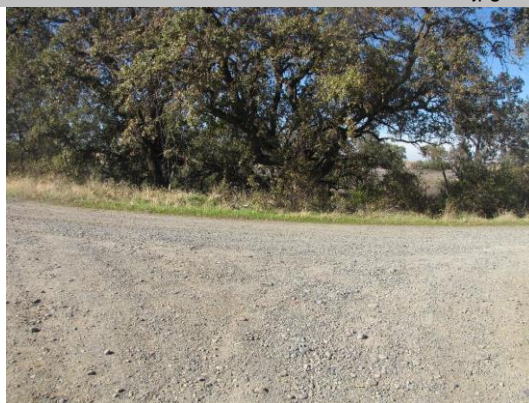
FS_ID:47973
DS_ID:17056
EP_NO: N/A
Repair Type: Non-Urgent
Crossing Status: Indicator Found
UCIP Comments: 4/26/2016 Unable to access area near structure.5/14/2013 Same as last inspection.11/14/2012 Abandoned Structure: WS- reminince of gates and concrete standpipe; LS-reminince of concrete headwall and pump station.
FIELD_STRUCT_DESC: *ABANDONED* [Western Canal Head Gate Inlet Structure] 2 of 2: 72-inch by 96-inch (8-foot by 8-foot) reinforced concrete culvert through the levee 25 feet below the crown. Three slide gates on the waterside (WS) end. Concrete stairs on the WS slope. Concrete headwall at both toes. [Additional Reference(s): DWR Levee Log, 2005. USACE Sacramento O&M Manual 152, March 1957 (Station 170+00)]
FS Date: 5/3/2016 12:37:00 PM
